MERITOR®

Technical Bulletin

Procedures and Intervals to Inspect the Wheel Ends and Tighten the Spindle Nuts on Meritor TL Series Trailer Axles with Unitized Wheel Ends

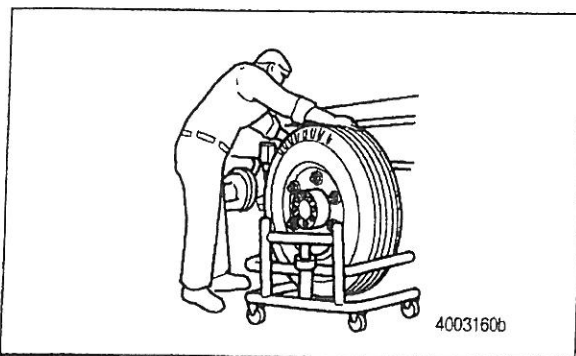
Figure 5

1. Follow the wheel manufacturer's instructions to remove the tire, wheel assembly and brake drum. Figure 5.
